SAFETYALERT

Safety Alert No. 418
April 22, 2021

Inadequate Job Planning and Change Management Leads to Injury

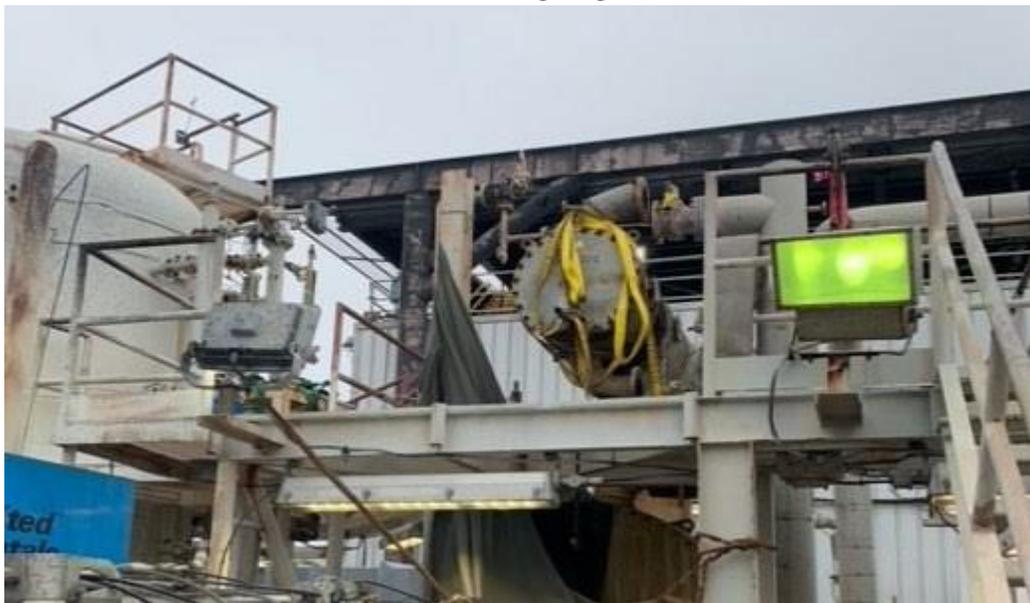
Figure 1: Location where handrail injury occurred

To free the last leg of the handrail from its socket, a crane equipped with a nylon sling attachment was used to apply upward tension while the crew used a 5-foot prybar leveraged underneath the kickplate. When the handrail suddenly broke free, the force of tension caused it to strike a crew member, knocking him to the ground and fracturing his nose and orbital socket. The crew member was transported to shore for medical evaluation, where doctors determined that surgery was required.

1. **Inadequate work planning** - the job steps did not cover the entire process to successfully remove the heater tube from the heat exchanger. The JSA should have been revised to include the job steps from the additional work that was added, including control measures to safely identify and mitigate all hazards involved with the task of removing the handrail.
2. **Inadequate training** - three of the five crew members were found to be deficient in their formal "company-specific" JSA training.
3. **Noncompliance with company policies** - none of the employees involved followed company policy to stop the job when the crew deviated from the tasks identified in the original JSA.

1. Assess, develop, and implement Leadership/Supervisory training and evaluation programs with periodic refresher training to ensure commitment and understanding of company SEMS policies and expectations.
2. Assess, develop, and implement in-house JSA and Stop Work Authority training and evaluation programs with periodic refresher training specific to company SEMS policies and expectations.
3. Ensure personnel discuss additional duties and hazards that come up with a change in work assignment. Use Stop Work Authority if hazards are not identified, or equipment is not adequate for the job.
